# City of Dade City

## AGENDA MEMO

**To:** Members of the Dade City Historic Board  
**From:** Jose B. Gil, P.E., City Engineer and Public Works Director  
**Subject:** Howard Office Park  
**Date:** 1/9/09

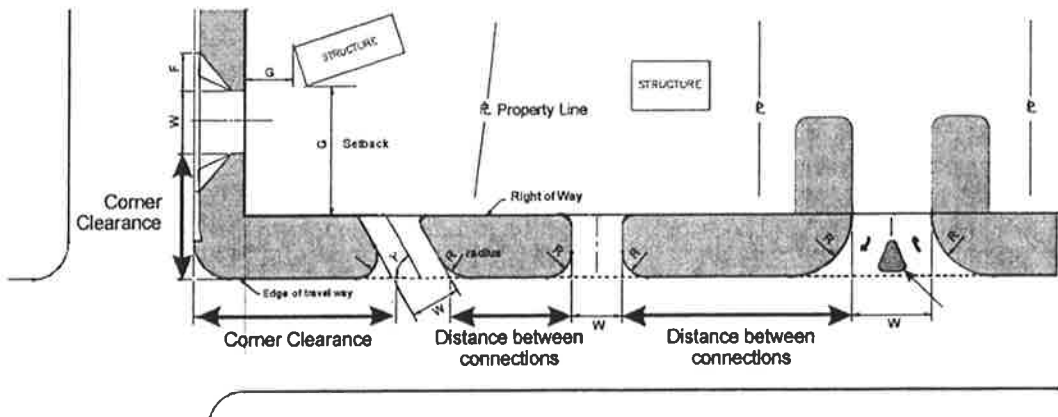
**Exhibit 59**  
Driveway Separation and Corner Clearance

Exhibit 59 is adapted from the Standard Index 515 and shows where the driveway connections are skewed, the distance would be measured from a projected edge of pavement.

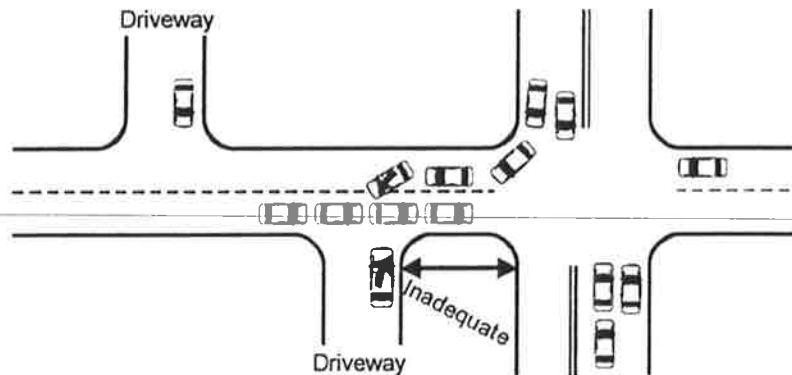
Exhibit 57  
Corner Clearance

Driveways and median openings close to a major intersection create a situation where the driver must negotiate conflicts close to an area that has been designed to manage large volumes of traffic. This situation can lead to poor safety and operational conditions. Proper driveway placement can help alleviate this problem. Proper driveway placement can also help the business operators, because traffic queues can become so long that traffic exiting driveways may be blocked for long periods of time.
